Manhole Inspection Summary

Manhole # S37KK_029MH

Insp Date: **3/19/07 11:24 AM**

Location Address: **1718 LAFEYETTE AVE**

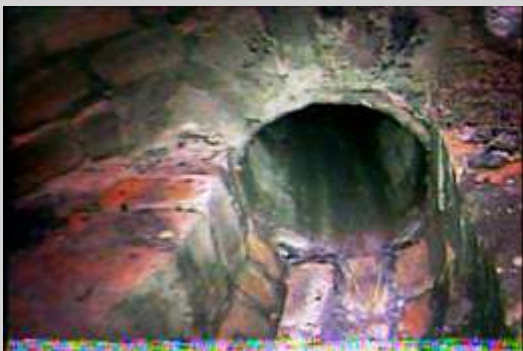
8 in. Circular Gravity Sewer Pipe In @ 3 O'Clock

Rod and Bar (Angled)

Pipe Material: **Clay** ☐ Pipe Lined

Infiltration: **None** Pipe Seal Cond: **Unknown**
